IMPROVED INPUT SHAFT FOR BMW R1150 6 SPEED MOTORCYCLE TRANSMISSION

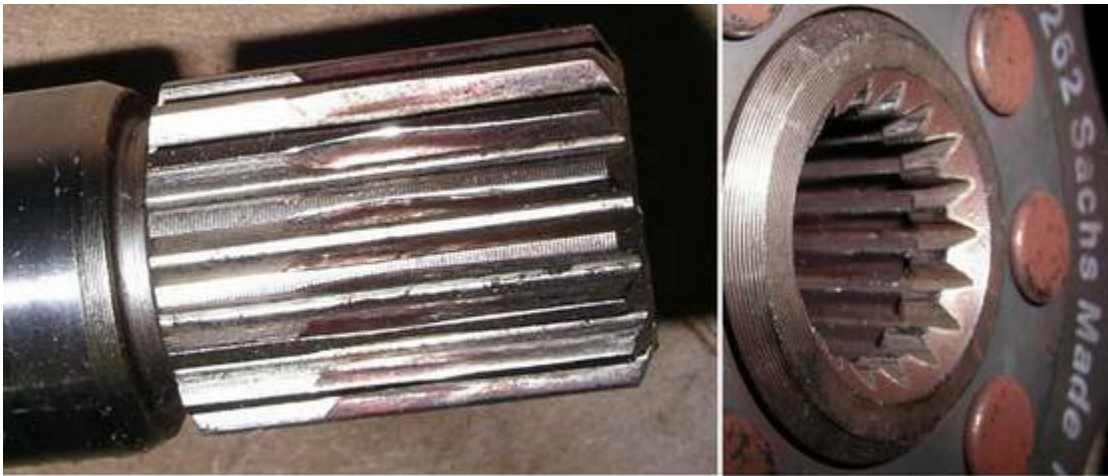
R1150GS Spline wear at 75k km. Clutch hub splines very worn, input shaft with noticeable wear

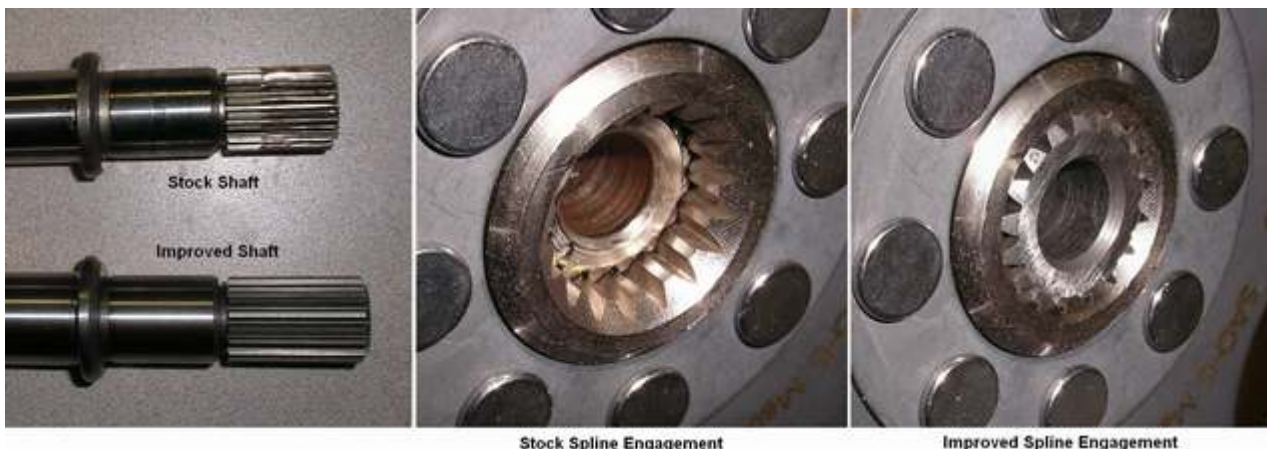
- Replaces BMW p/n 23 21 7 651 172. Fits all R1150 6 speeds
- Shaft material is harder than OE and splines have reduced backlash to further reduce wear.
- Professionally manufactured to ISO9001, API Q1 & AGMA standards by a large North American Manufacturer.
- BMW allows 11 labor hours to replace this part so a longer life part only makes economic sense.
- Original prototype now at 126,000mi (203,000km) in my own machine
- By combining with the *Extended Hub Clutch Disc* from Beemerboneyard an additional 6mm of spline area can be achieved for a total of 12mm.
- Price: \$855usd insured postage included to the contiguous USA. Paypal Accepted.
